GRAVITY GRADIENT STABILIZATION SYSTEM for the

APPLICATIONS
TECHNOLOGY
SATELLITE

SIXTH QUARTERLY PROGRESS REPORT

SIXTH QUARTERLY PROGRESS REPORT
FOR THE
APPLICATIONS TECHNOLOGY SATELLITE
GRAVITY GRADIENT
STABILIZATION SYSTEM

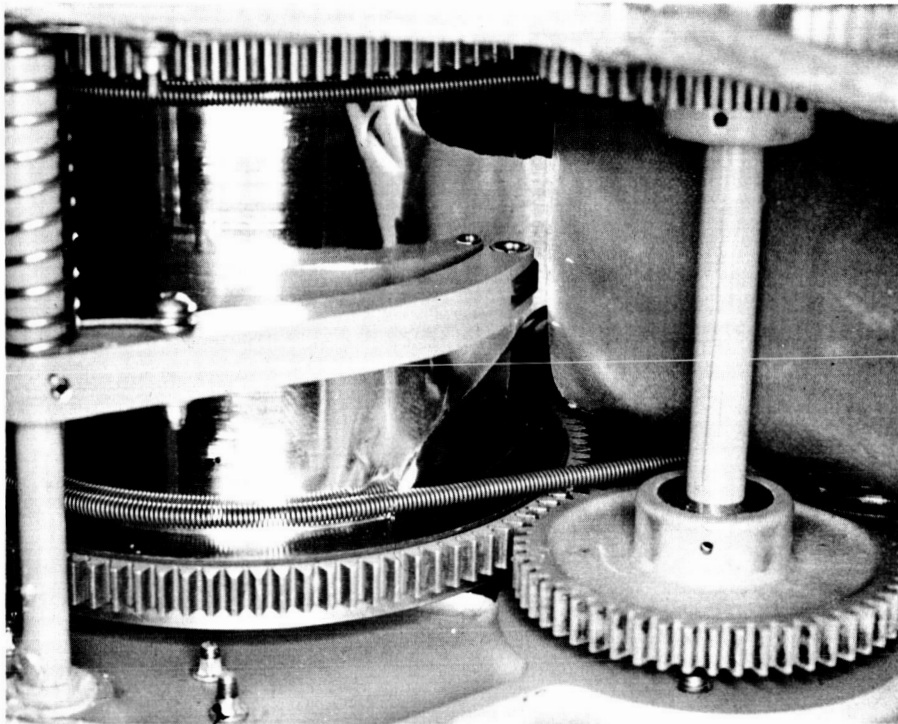
Both sideplates of the disassembled erection unit (Boom 2) were found to be similarly affected. The Boom 1 drum bearings were found to be hung-up in a like manner but this unit was not completely disassembled at the time.

Figure 3-16. Erection Unit 2 Boom Element Failure,
T-1a Primary Boom Assembly

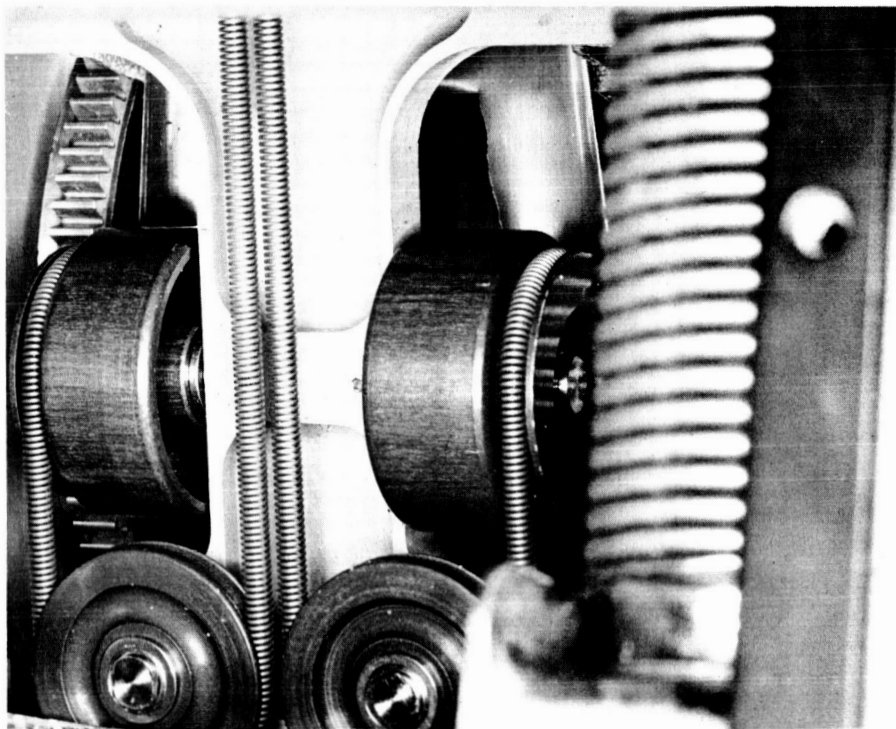
Figure 3-17. Erection Unit 2 Boom Element Failure, Reverse Side

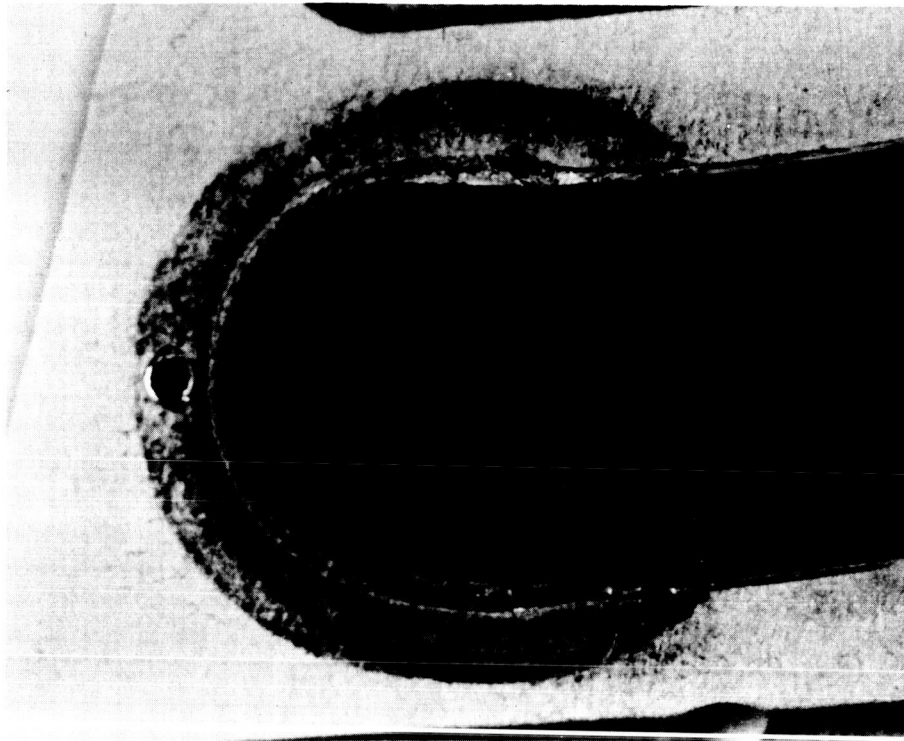
Figure 3-22. Bearing Stress Failure of Kidney Slot

It was therefore concluded that the kidney slot hang-up (and resultant misalignment) is the problem to be attacked in precluding the reverse-wind failure. The redesign for this condition is to provide a much larger bearing area under the flange and a chamfer as shown in Figure 3-32.

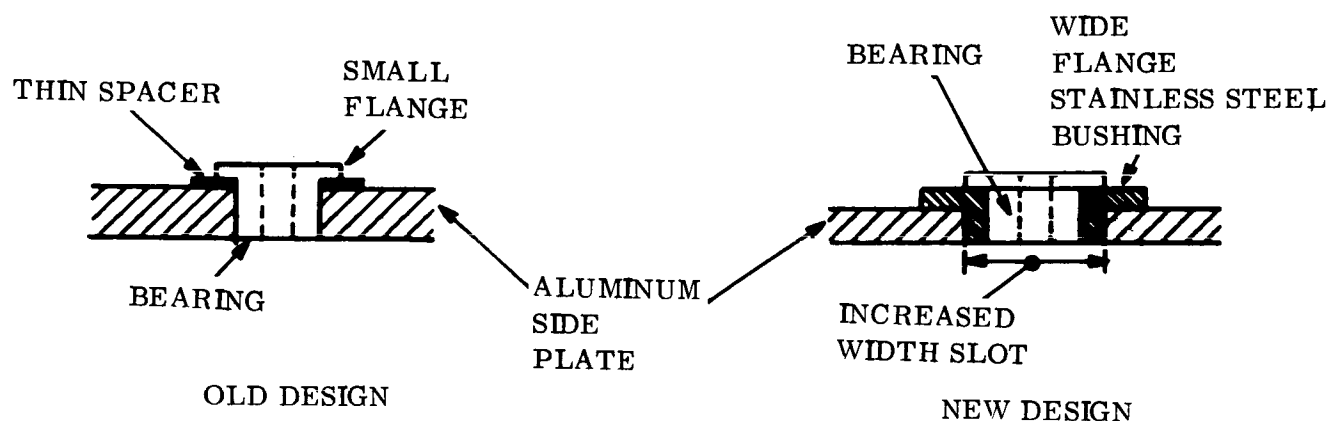
Figure 3-32. Redesign of Flange to Correct Reverse Wind Failure

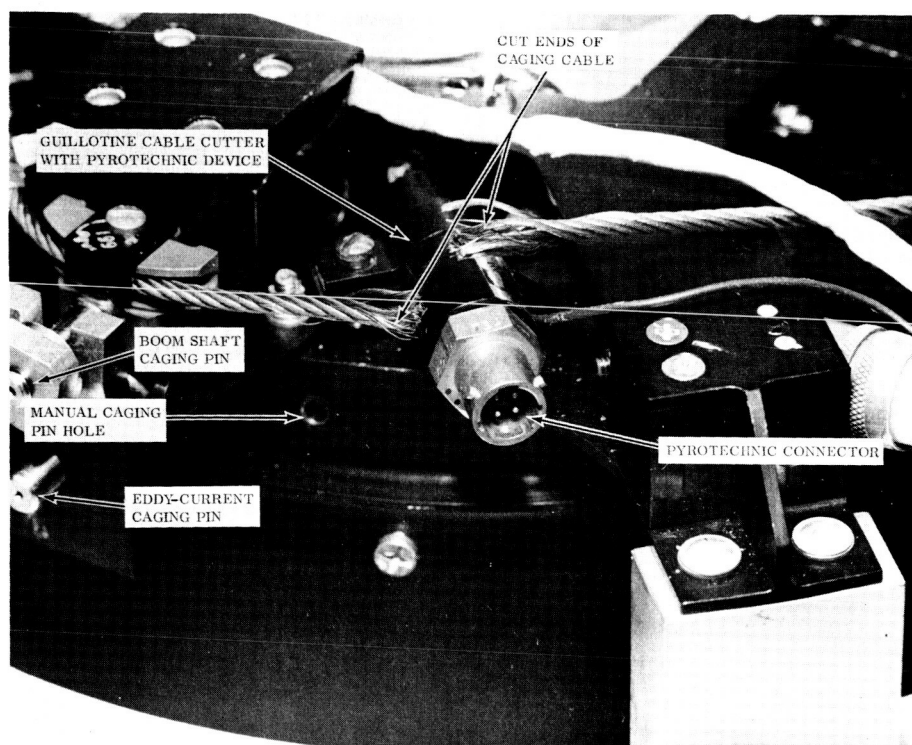
The first test performed following assembly of Engineering Unit 1 was an uncaging exercise. The guillotine cable cutters were electrically detonated. Figure 4-9 shows that all strands of the caging cable were completely cut by the uncaging guillotine. The right-hand part of the caging cable was placed on top of the baseplate especially for this picture: it is normally threaded through a clearance hole in a web of the baseplate. The connector on the right with its white power leads and dark ground wire was disconnected from the pyrotechnic device at the time the picture was made. When connected for firing,

Figure 4-9. Caging Cable (at Pyrotechnic Device 1) After Uncaging Operation, CPD Engineering Unit 1

this connection would normally be inserted into the bayonet end of the pyrotechnic device shown at the center of the picture. (Figure 4-4 shows connector mated.) The bracket with four holes (shown in left of picture) is used for the boom release mechanism. The boom mechanism release is shown in Figure 4-4. The square nut, at the left-hand edge of Figure 4-9, is on the end of the boom caging pin and is used to adjust the force on the eddy-current caging pin which, in turn, is located just below. The open hole, identified in Figure 4-9, is used for the manual caging pin.

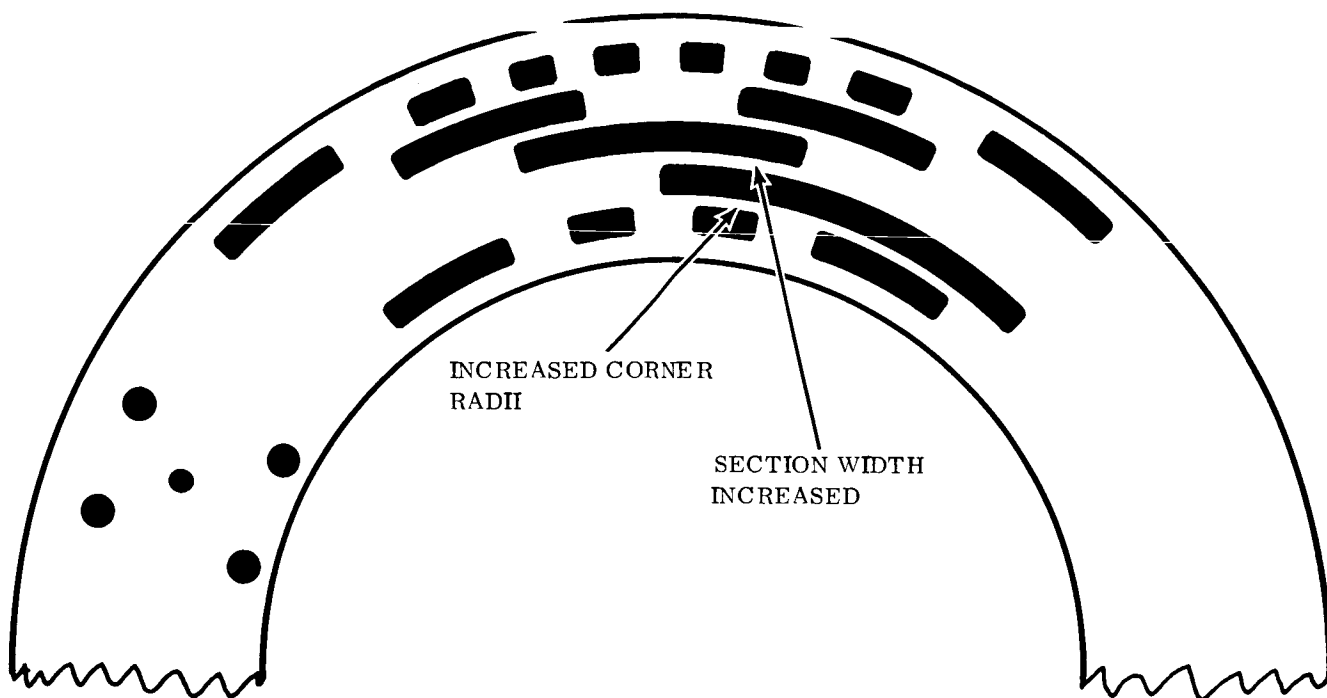
Figure 4-12. New Encoder Disc Design

The new discs will be subjected to a qualification level vibration test prior to installing it into future units. The design shown in Figure 4-12 incorporates the changes mentioned

in (a) and (b) above and this design is being fabricated in several materials for test evaluation. Comparison of Figures 4-11 and 4-12 will reveal that there has been some transposition of the various bits. These transpositions provide more physical support of all cut-out sections. The increased corner radii are also readily apparent in Figure 4-12.

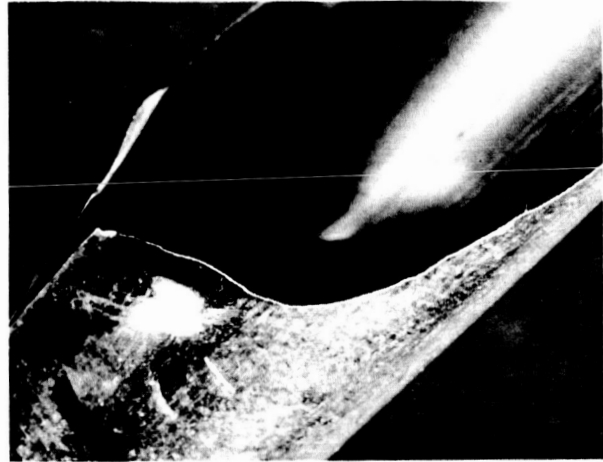
Figure A-2. Edges of Rod 2 Showing Origin of Failure (Magnification 4X)

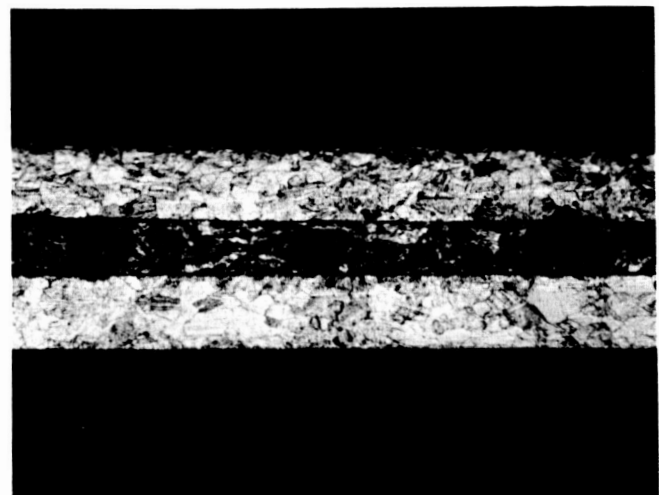
Figure A-4. Photomicrograph Along Edge of Tube Cross-Section (Magnification 250X)

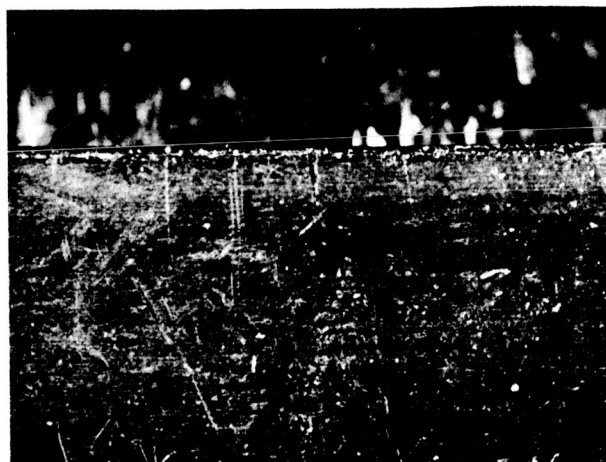
Figure A-6. Edge of Tube Overlap Showing Cracks Along Edge (Magnification 25X)

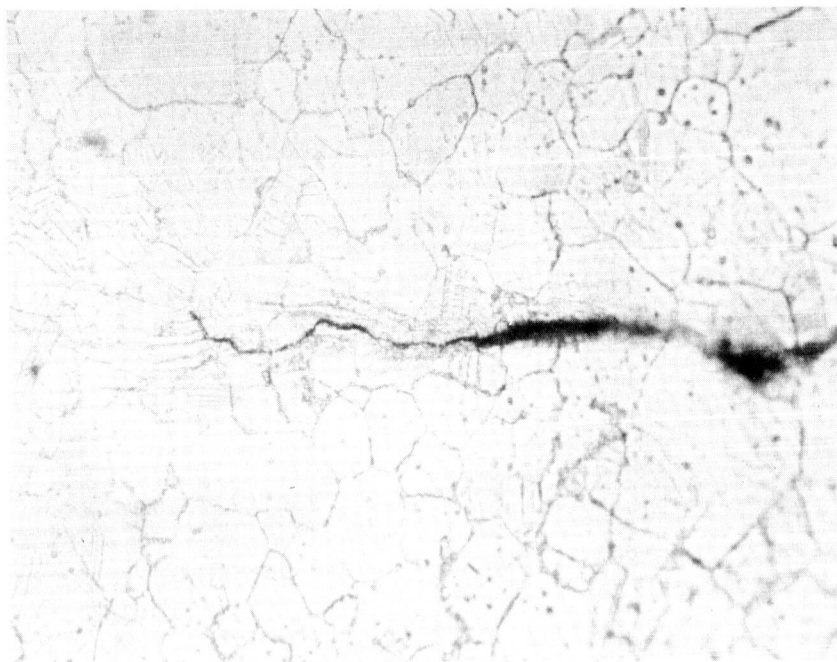
Figure A-7. Photomicrograph Taken in Region of Crack Shown in Figure A-6

failed at this point and the tear progressed in two directions from that point.
